Mahaanui Kurataiao Ltd

# Ōtākaro Cultural Monitoring Report

June 2024

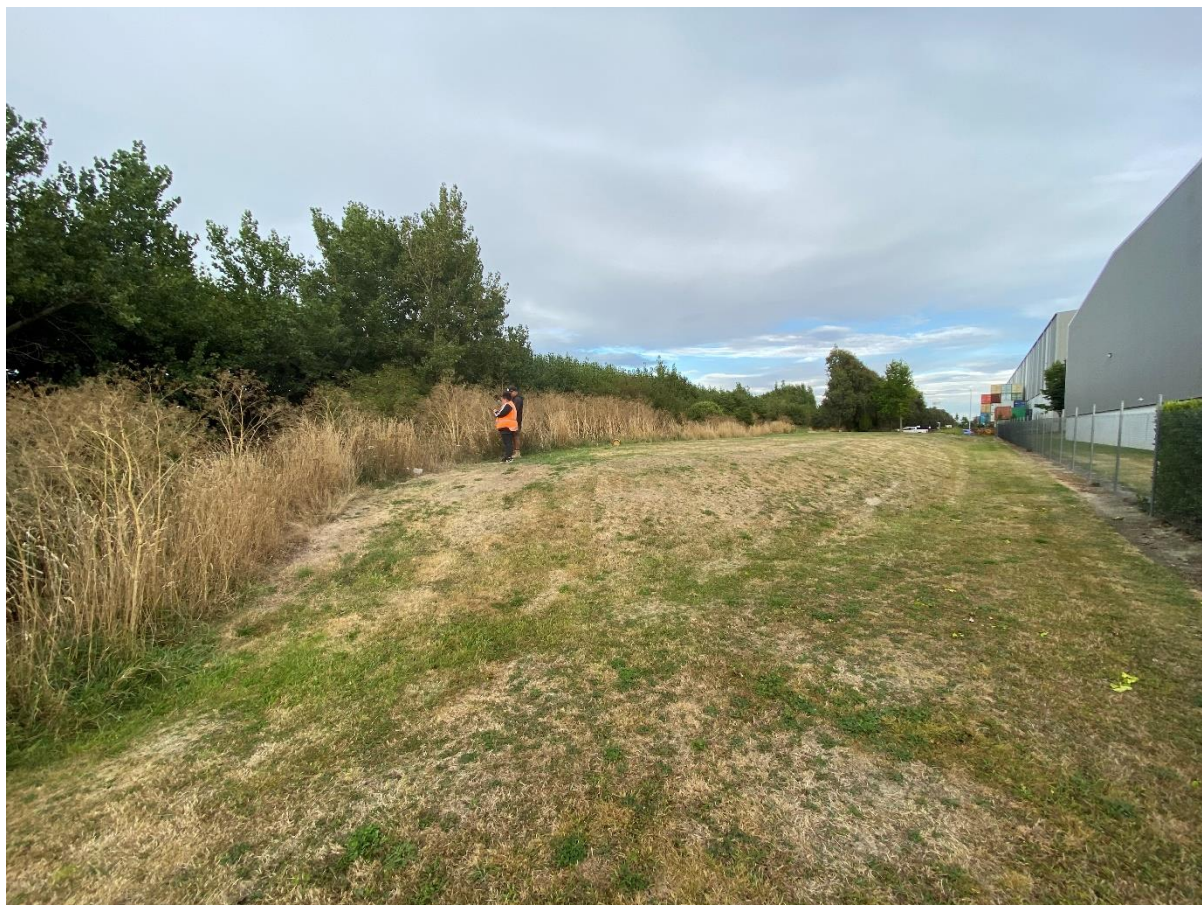
Figure 10. Looking west at the historic site for the Ōtākaro headwaters.

therefore it could be interpreted incorrectly with regards to cultural stream health. Actions to restore mahinga kai at this site include: clearing all weeds and exotic vegetation from the historic stream channel and along bank margins, planting native vegetation, and restoring water flow.

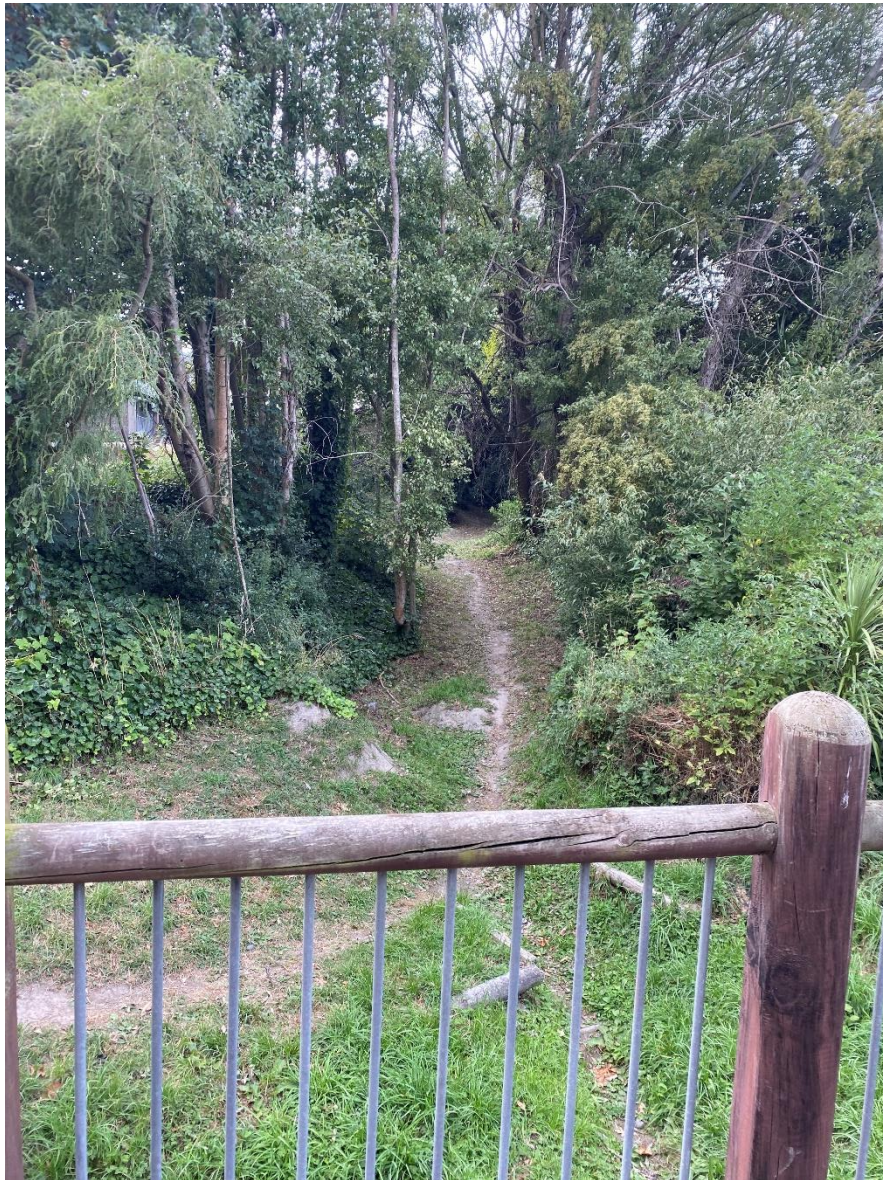
it was noted that it appeared to have been dry for quite some time. Historic stream channel has been turned into a walking track which is used by a range of recreational users, including runners, dog walkers, and mountain bike riders.

**Figure 11. Picture of historic Waimairi Stream channel, looking east (downstream).**

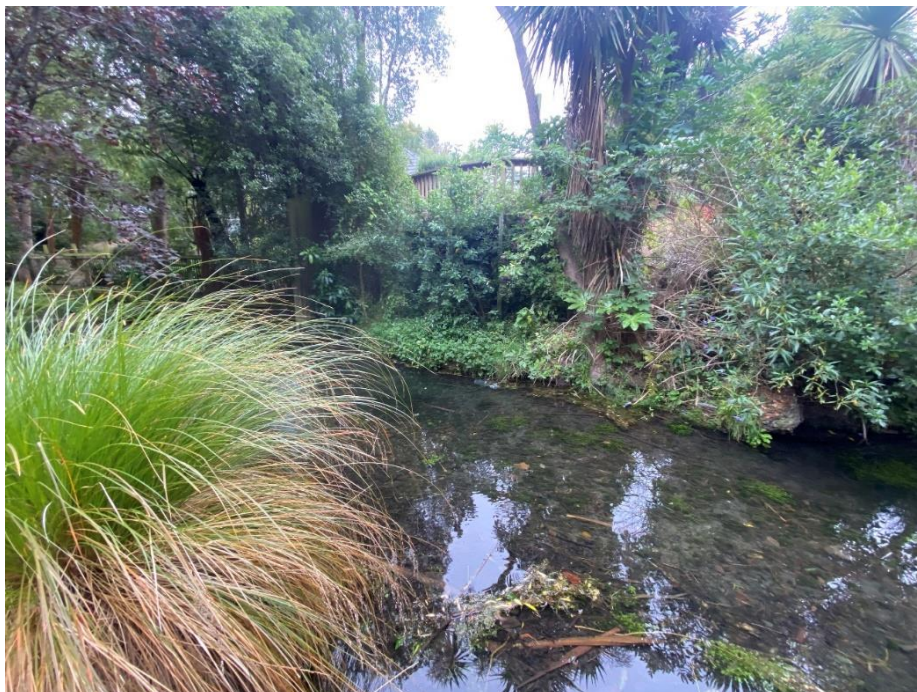
SOT scores for Site 4 were slightly better than scores from the previous 3 sites, however they were still poor values on average. Scores ranged from 1.5 to 2.5 across all categories, with overall health being scored a 2.5. There were some positive aspects to this site, such as some of the native vegetation planting that has been undertaken recently along the true right side of the stream bank. There were also some negative aspects, with the most notable being the very short set backs from neighbouring residential dwellings along the true left side of the stream. Many dwellings had fences and decking built within the waterway setback, as well as some stormwater discharge points directly into the waterway from their properties. These all had considerable impacts on SOT and CHI scores, in particular with mahinga kai harvest. CHI scores were better at this site as well, with most categories scoring between 3 and 3.5. There were still some very poor scores at this site, including the use of riverbanks and margins and changes to the river channel, which were both scored 1. This was directly related to the neighbouring residential dwellings along the true left side of the waterway and the level of intrusions within the waterway setbacks. One gee minnow trap was set along the true left bank of the stream and caught 12 common bullies. Fish were juvenile and ranged between 20mm and 35mm in size.

Figure 13. Photo of Wairārapa Stream looking north.

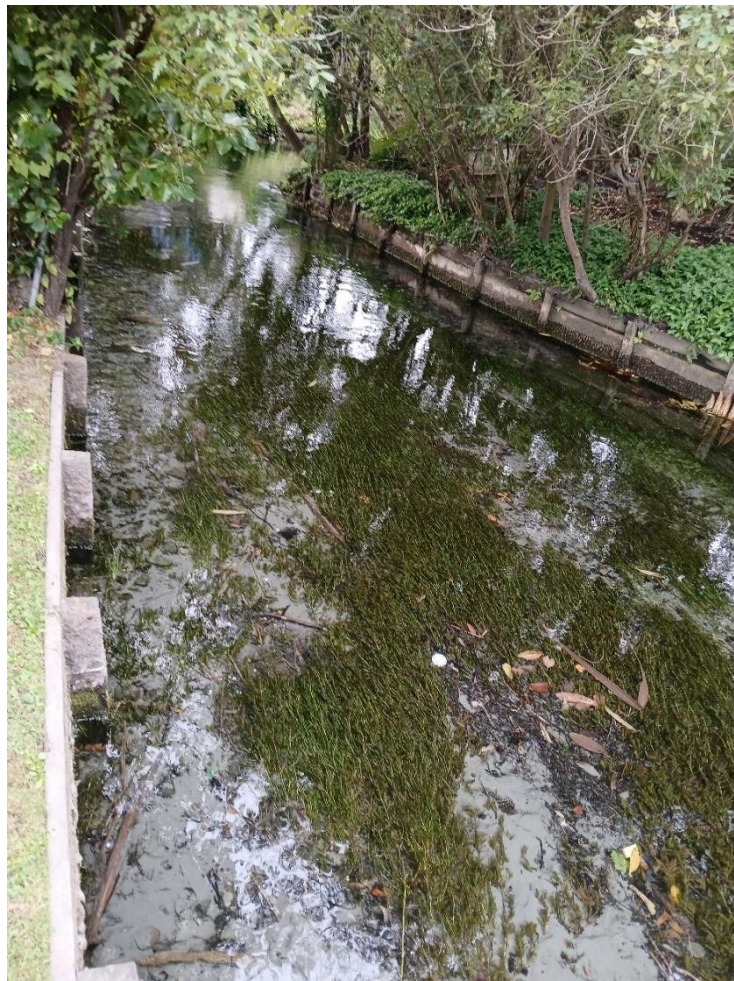
SOT scores for Site 5 were varied across all categories. Scores ranged from 1 to 4, with overall health being scored a 4. The degree of modification at this site was extreme, with monitors noting neighbouring residential dwellings along both sides of the waterway, stormwater discharge pipes directed into the waterway, wood and stone lined retaining walls, and straightening. Although water appeared very clear and free of contaminants, monitors noted that there was a high degree of sediment build up throughout the stream bed. CHI scores for water clarity and water quality were both very good, with both scoring 4.5. Overall health was scored a 4, with concerns around the lack of native vegetation, instream vegetation, and lack of riparian planting all impacting overall scores. One gee minnow trap was set along the true right bank and left overnight. One small longfin tuna was caught and observed by monitors. It was measured as approximately 530mm in length.

Figure 14. Photo of Waimairi Stream looking north (downstream).

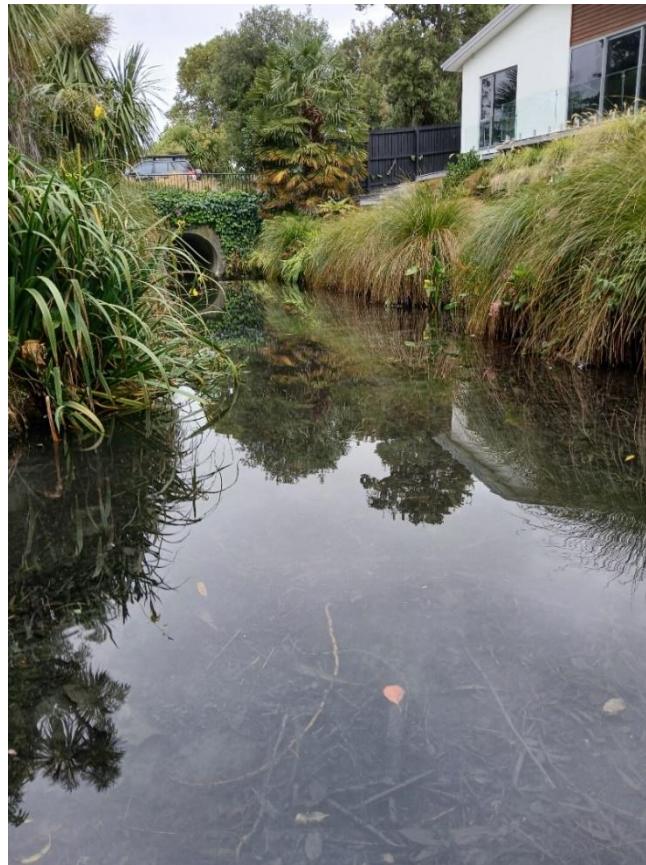
SOT scores for Site 6 were consistent, with most categories scoring between 1.5 and 2. Overall health at this site was scored a 3.5, which was a moderate value. Concerns at this site included the surrounding land uses, neighbouring residential dwellings and the extent of their waterway setback intrusion, stormwater runoff from the residential dwellings, and the silt/sediment build up instream. CHI scores were more varied, with scores ranging from 1 to 4. Use of riverbanks/margins and changes to river channel both scored a 1 while water clarity was scored a 4. It was noted that there are natural springs mapped near this site (upstream) which may have an impact on water quality and clarity for this stream. One gee minnow trap was set along the true right bank of this waterway; however no fish species were caught overnight.

**Figure 125. Photo of Ilam Stream looking east (downstream).**

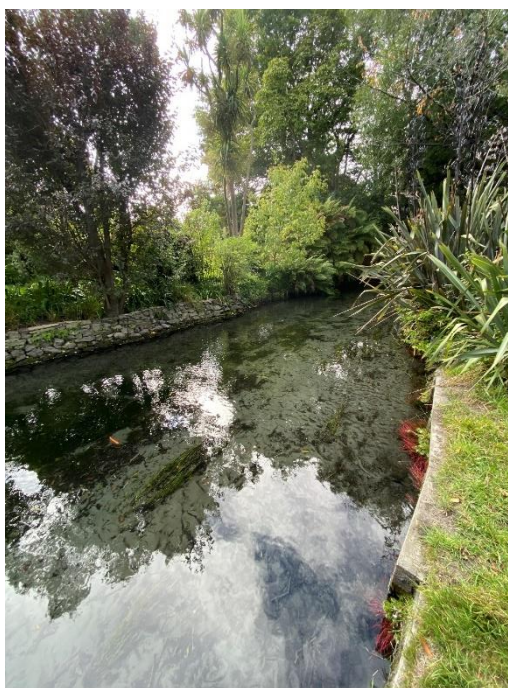
bridges, culverts, and retaining walls in the surrounding area, as well as what appears to be stormwater discharge outlets from neighbouring residential dwellings which discharge directly into the waterway. Overall health was scored 3.25 on average, with aspects such as level of silt and sediment build up along the stream bed, human rubbish within the waterway, and level of riparian planting all impacting the scores. CHI scores were similar, with most categories scoring between 2 and 3.5. Use of riverbanks/margins and changes to river channel were both scored a 1, while water clarity was scored a 4.5. Monitors identified the following actions required to restore this site as a mahinga kai: native planting (in particular riparian planting to increase fish and bird habitat), removal of trash and silt within the waterway, and improving signage in the site that explains the historic importance of this site for Māori, as monitors stated that there was once a pā site within Pūtārikamotu Deans Bush. One gee minnow trap was set along the true left bank and caught a total of 26 common bullies overnight. This was the highest abundance of common bullies caught across all monitoring sites, with the same number of fish also being caught at Site 11 – Te Oranga Horseshoe Lake. The common bullies that were caught ranged in size from approximately 25mm to 65mm.

Figure 16: Photo of Ilam Stream looking east (downstream).

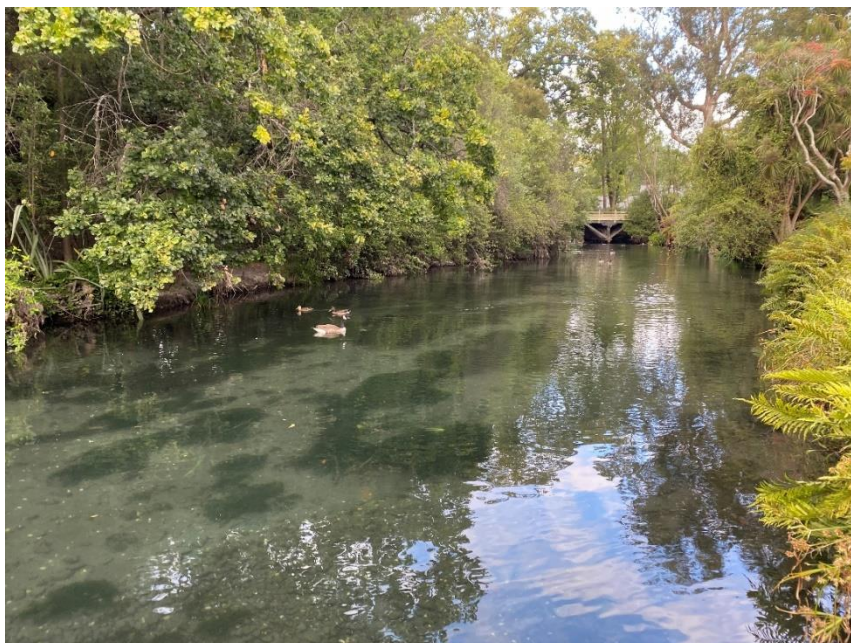
harvesting and mahinga kai harvest both scored a 4 overall, with monitors indicating that site was accessible with easy access to the waterway from the jetty, and that they would come back to harvest mahinga kai with a variety of indigenous vegetation and fish species available. The site was scored a 4 for overall health. Monitors noticed some rubbish floating in the waterway which impacted this score, and also noted an increase in native riparian planting would increase the overall health of this site. CHI scores were mostly consistent, with many of the categories scoring a 4 or 4.5. The fish survey conducted at this site included setting one gee minnow trap and one hīnaki (fyke net) along the true left bank, which were both left overnight. In total 13 common bullies were caught along with 5 tuna. The common bullies ranged in size from 25mm to 60mm. While monitors were observing the tuna one managed to escape back into the waterway before it could be accurately identified and measured. It was estimated that this tuna was approximately 730mm in length. After this tuna had escaped the monitors then used a small amount of clove oil to sedate the fish so they could be measured and identified more accurately. Of the remaining tuna, one was identified as shortfin while the other three were identified as longfin. The 3 longfin tuna were measured at approximately 600mm, 650mm, and 850mm. The one remaining shortfin tuna was measured at approximately 650mm. Once fish were identified and measured they were transferred to a recovery bucket of water before being transferred back into the waterway once they had regained consciousness. An electric air pump was also used in the recovery bucket to increase oxygen levels for the fish.

Figure 17. Photo of Ōtākaro/Avon River, looking west (upstream).

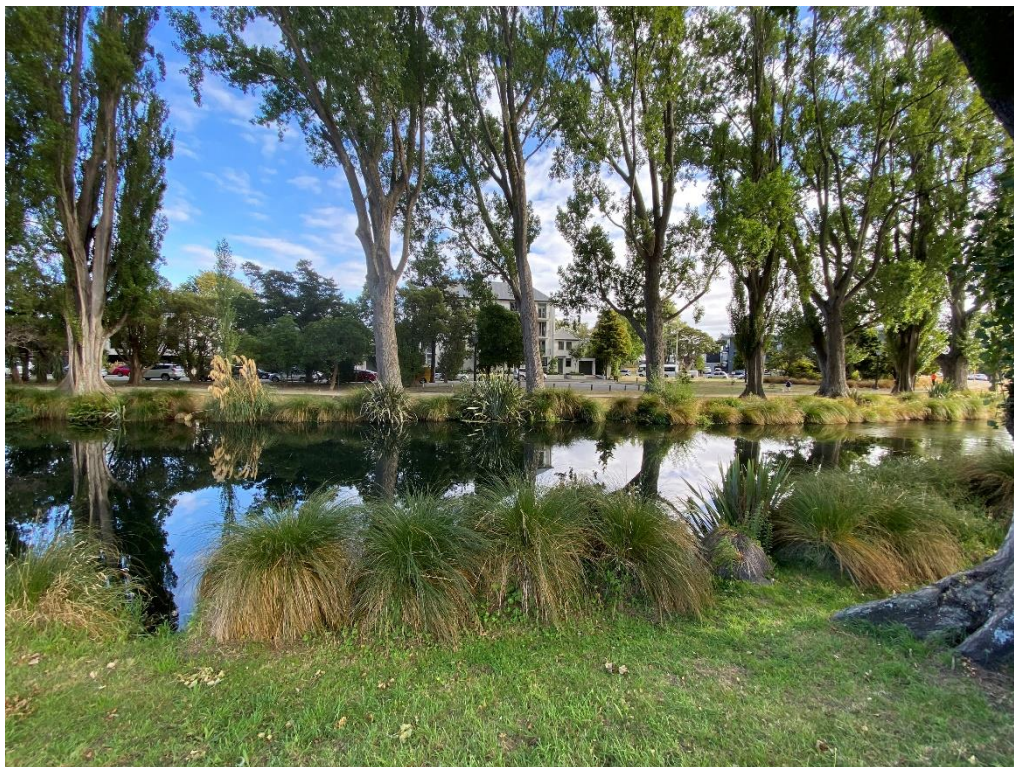
SOT scores at Site 9 were varied, ranging from 1 to 3 across all categories. Although there were no extensive barriers identified with site access, there were a number of issues noted that impacted overall health. These were site pressures from the surrounding land use (for example the intensive housing on one side of the river and the urban park on the other), and the various stormwater runoff from surrounding roads and footpaths. Overall health for SOT was scored a 3 on average with rubbish and weeds within the waterway being identified as the main influencers for this. CHI scores were typically between 2-3 for most categories. Riverbed conditions were scored a 1 due to the abundance of weeds instream. Only one gee minnow trap was set at this site for the purpose of conducting a fish survey. Monitors had originally planned to set one hīnaki however stream depth was too deep to safely install a net. The abundance of weeds as well as other recreational users of the river were also factors in preventing a hīnaki being installed at this site. Eight common bullies were caught overnight in the gee minnow trap, ranging in sizes from approximately 65mm to 105mm. No other fish species were caught at this site.

Figure 18: Photo of Ōtākaro River facing north.

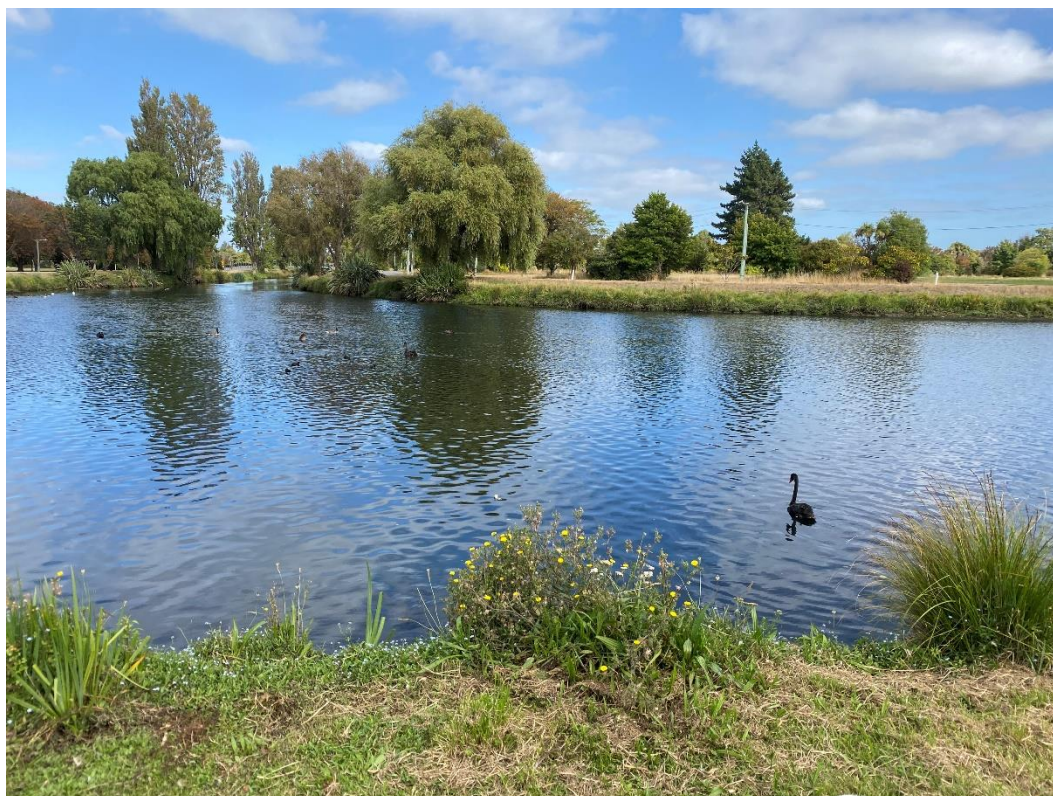
The SOT scores for Site 10 varied from 1.5 for degree of modification to 4 for site access for harvesting. Actions such as restoration of native species, increasing native riparian planting, and pest/weed control were identified by monitors to improve site health. This site is within Christchurch's Residential Red Zone where land has been identified as unsuitable for buildings. This has resulted in the surrounding landscape becoming very bare since the 2010/2011 Christchurch earthquakes with all residential housing being demolished. The only buildings that remain at the site are the rowing club and facilities. The surrounding land use at this site is predominately recreational, with mainly rowers and fisherman using the river. Other recreational users include kayakers, runners and dog walkers. CHI scores were similar, with scores ranging from 1.5 to 4 across the categories, with overall health scoring a 2.5. Monitors noted that more native vegetation planting and native riparian planting was needed to help restore this site as a mahinga kai. One gee minnow trap was set along the true right bank as part of the fish survey for this site. In total there were 18 common bullies caught overnight, ranging from approximately 50mm to 100mm in length. One deceased common bully was also found in the gee minnow trap, which was approximately 20mm in length.

Figure 19: Photo of Ōtākaro river at Kerrs Reach, looking west across the river.

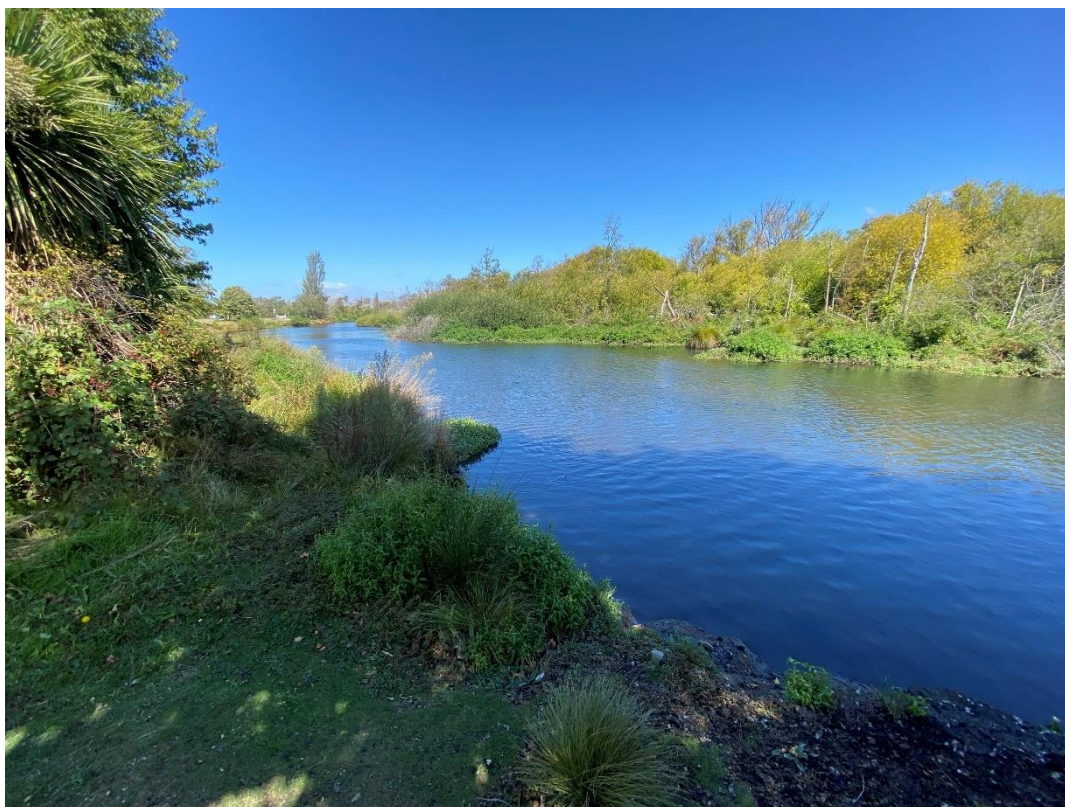
SOT scores for Site 11 were varied, ranging from 1 to 3.5. Mahinga kai harvest was the lowest scored category, as the site was observed as being too polluted from bird excrement. CHI scores were lower on average, with most categories scoring either a 1 or 1.5 on average. Water clarity was very poor at this site, with lakebed conditions being very soft and predominantly made up of silt and mud. There are also multiple stormwater discharge points from nearby residential dwellings and roads which discharge untreated stormwater directly into the waterbody. This would have a significant impact on water quality within Horseshoe Lake, in particular during heavy rainfall events. One gee minnow trap and one hīnaki were set along the true left bank and left overnight for the purpose of conducting a fish survey. In total two common bullies, one giant bully, one shortfin tuna and three longfin tuna were caught. The two common bullies were estimated to be between 25mm and 30mm in length. The giant bully was measured at approximately 120mm in length. The three longfin tuna were approximately between 600mm and 850mm in length, and the one shortfin tuna was approximately 650mm in length.

Figure 20: Photo of Te Oranga Horseshoe Lake, looking south (downstream).

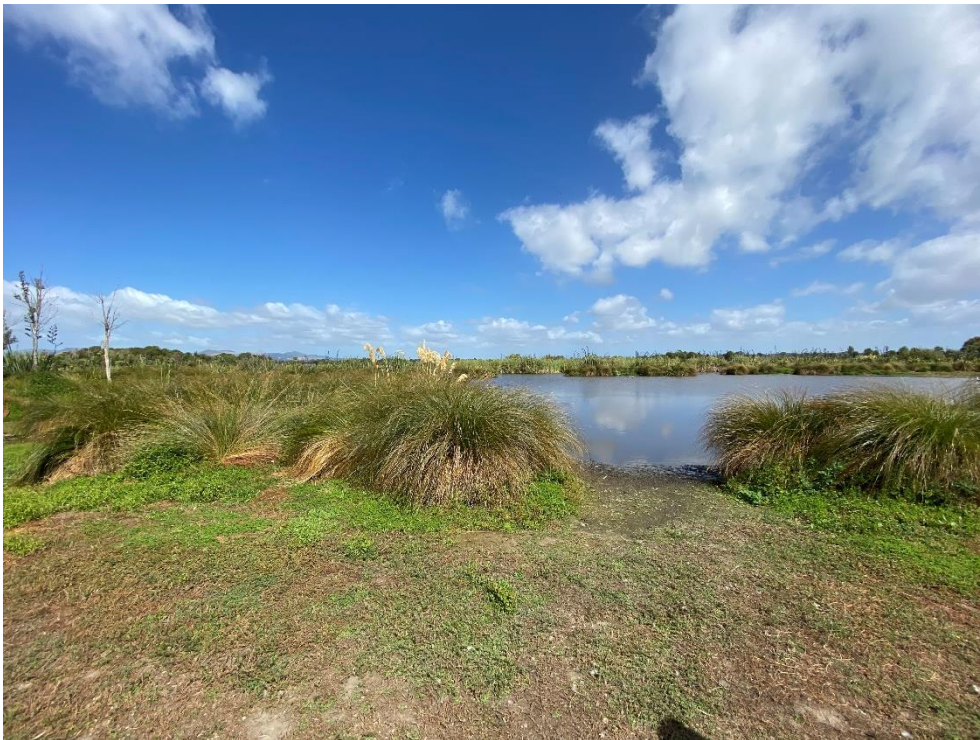
SOT scores at Site 12 were much more positive than from previous sites. Scores ranged from 3.5 to 5. Monitors scored access for harvesting a 5 (very good) as they felt there were no restrictions to accessing mahinga kai to harvest. Overall health was scored a 4.5, with monitors stating the contaminants from the high abundance of bird species would have a negative impact on water quality here. CHI category scores varied from 1 (variety of habitats) to 4.5 (catchment landuse). Variety of habitats scored very poorly due to the waterbody not having any current or depth variability. It was noted with monitors however that the site was a natural wetlands, which can make it difficult to assess against SOT and CHI assessment questions as they are designed for assessing streams and waterways. The majority of questions from the SOT and CHI however are still relevant for this site and provide important information. Monitors noted that there were no major concerns observed at this site, and how beautiful the natural wetlands are. The only concerns raised by monitors were regarding the potential contamination from the abundance of bird species throughout the site. Continuing to plant more native vegetation at this site was noted as an action that monitors would like to see happen in the future, to continue restoration and enhancement of this site as a mahinga kai. Monitors were unable to conduct a fish survey at this site due to the low depth of water throughout the wetlands during the time of monitoring.

Figure 21: Photo of Ōruapaeroa Travis Wetlands, looking southwest from monitoring location.

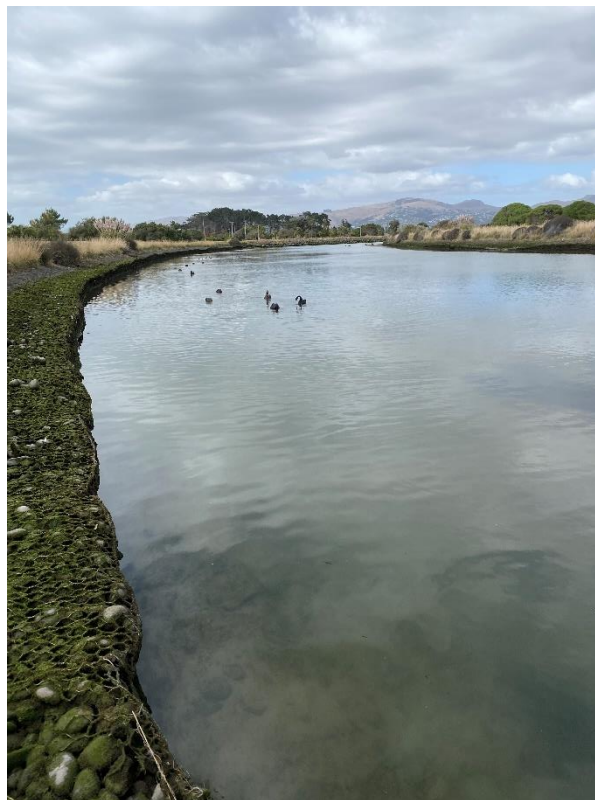
SOT scores at Site 13 were mostly poor, with scores of 1 to 1.5 for all but one category. Access for harvesting was the exception which scored 3.5. Reasons for poor scores were the level of discharge that was occurring at this site, the degree of modification that has occurred such as the bridges and stopbanks that have been built up, and the amount of toxic algae that is present in and around the water. CHI scores were consistent, with all categories being scored between 1 and 2 on average. Riverbed conditions were very poor, with a lot of sediment, silt, and mud build up with minimal plants rooted in the riverbed. Water clarity was also poor, and in most places monitors were unable to see the bottom of the riverbed. Due to the level of discharge occurring at this site monitors indicated they would not harvest any mahinga kai that may be present. Two gee minnow traps were set along the true left bank of the waterway and left overnight to conduct a fish survey. In total there were 11 common bullies, 4 giant bullies, 1 shortfin eel, 2 unidentified baby eels, and 2 unidentified deceased fish caught in both gee minnow traps. Common bullies ranged between approximately 55mm to 110mm in length, while giant bullies were measured at approximately 70mm to 80mm in length. The shortfin eel was measured at approximately 660mm in length and the unidentified baby eels were approximately 170mm to 220mm in length.

Figure 22: Photo of Ōtākaro looking downstream (south).
