# Charlesworth Drain Water and Sediment Quality, and Īnanga Spawning

July 2025

**Prepared for:**  
Christchurch City Council

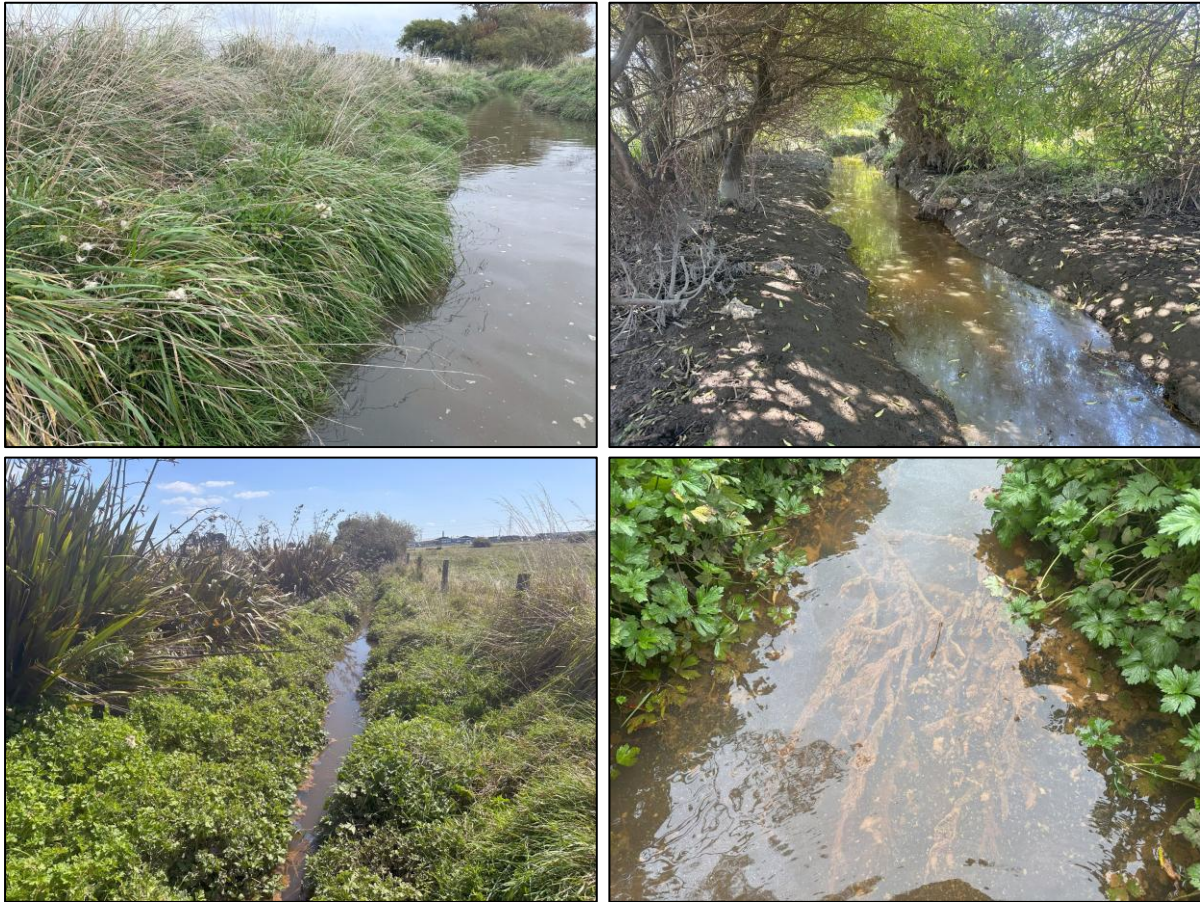
*Figure 9: Riparian conditions within Īnanga spawning range, including dense grasses downstream of road (top left), absence of spawning vegetation under willows immediately upstream of farm road (top right), and dense bushels of buttercup (*Ranunculus* sp.) (bottom). Note sedimentation and suspended orange iron floc in water column.*

No Īnanga eggs, nor any adult Īnanga, were observed in Charlesworth Drain during any sampling period despite extensive searching. Despite the absence of observed Īnanga spawning, Charlesworth Drain contained extensive areas of suitable spawning habitat, particularly in the lower sections of the survey area downstream of the main farm road. These lower areas were dominated by long grasses, while the upper sections featured buttercup with scattered flaxes. However, suitable habitat was limited immediately upstream of the farm road culvert, where groundcover was often sparse due to shading from willows (Figure 9). Areas dominated by buttercup and grasses offered high-quality spawning conditions, with dense stems and root mats that retained moisture well. In contrast, sections shaded by willows lacked adequate ground vegetation, making them unsuitable for Īnanga spawning.

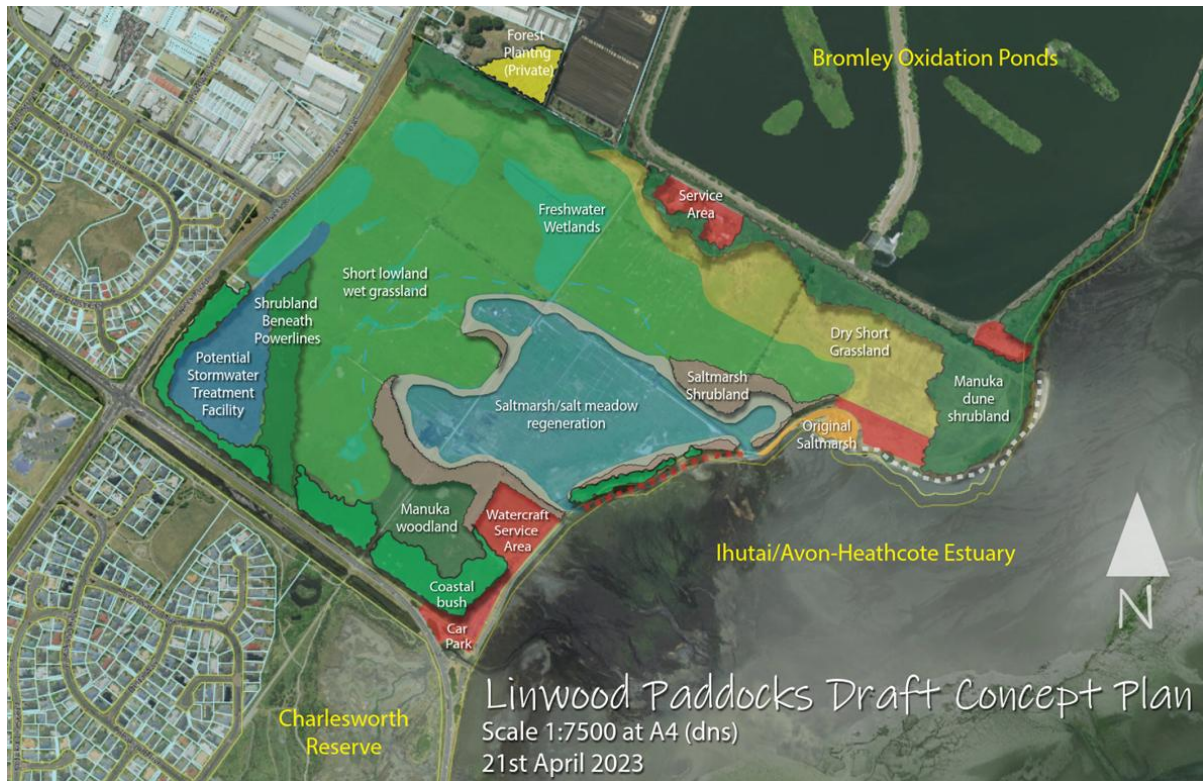
## APPENDIX 1: LINWOOD PADDOCKS CONCEPT PLAN

Provided by Andrew Crossland, Christchurch City Council, 3 December 2024.

Linwood Paddocks is an area of farmland owned by Christchurch City Council that borders the Estuary of the Heathcote and Avon Rivers / Ihutai. Although the paddocks have been drained for farming, they remain wet, support significant bird habitat, and form part of the estuary Site of Ecological Significance in the District Plan (SES/LP/14). There are plans to naturalise Linwood Paddocks, by creating a mosaic of wetland and dryland habitats (see Appendix 1).
